TEST REPORT

**CRASHWORTHINESS TESTING
OF AEV TRAMAHAWK TYPE III AMBULANCE**

AMERICAN EMERGENCY VEHICLES

**GENERAL TESTING LABORATORIES, INC.
1623 LEEDSTOWN ROAD
COLONIAL BEACH, VIRGINIA 22443**

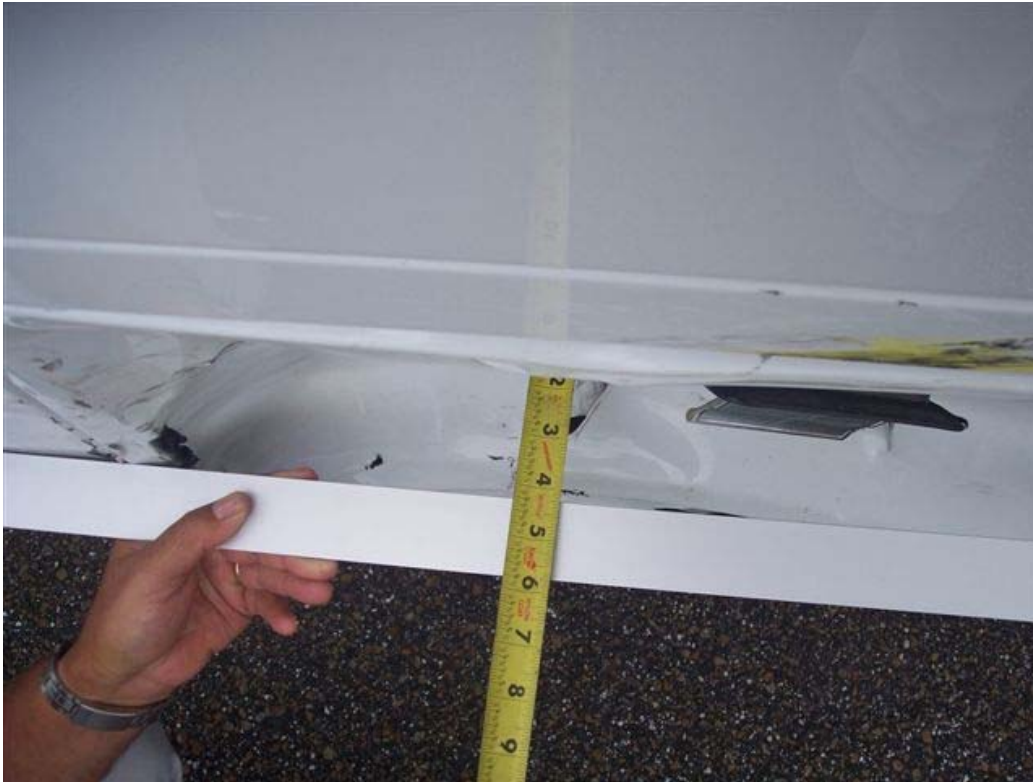
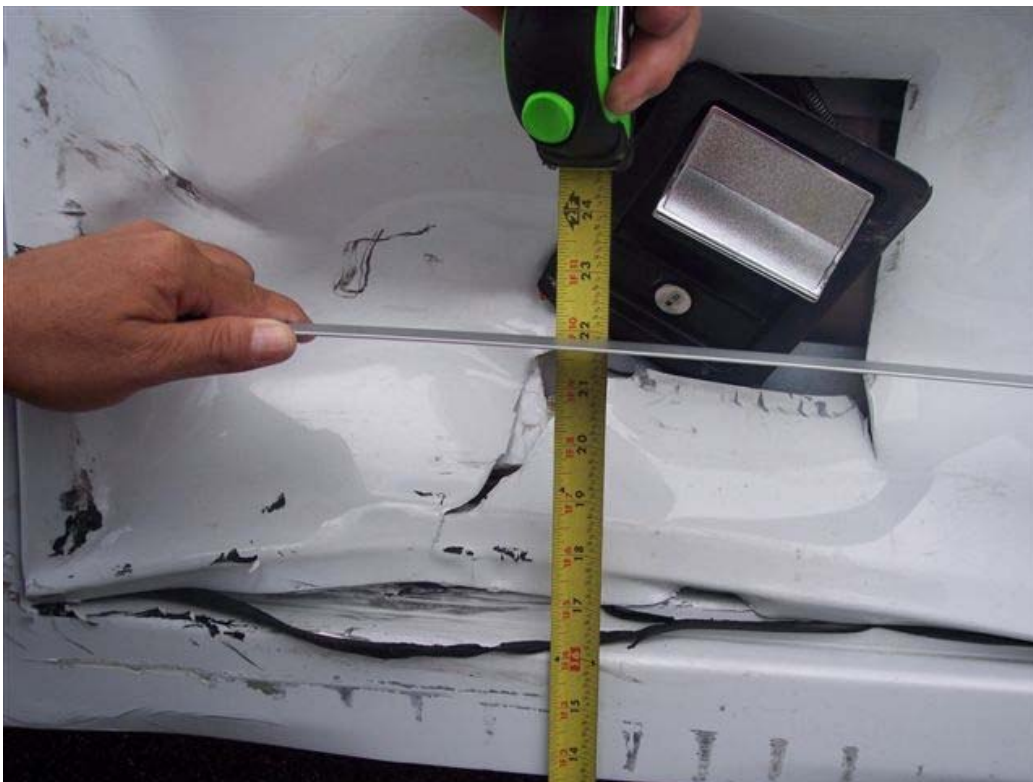
TEST #	AMBULANCE DEFORMATION		
	LOCATION	DISTANCE FROM GROUND	STATIC CRUSH
GTL052	RIGHT SIDE BATTERY COMPARTMENT	21 7/8"	4 1/4"
GTL055	LEFT SIDE STORAGE COMPARTMENT	23 3/4"	2 5/16"

RIGHT SIDE IMPACT SHOWING MEASUREMENT OF MAXIMUM CRUSH (TEST #052)

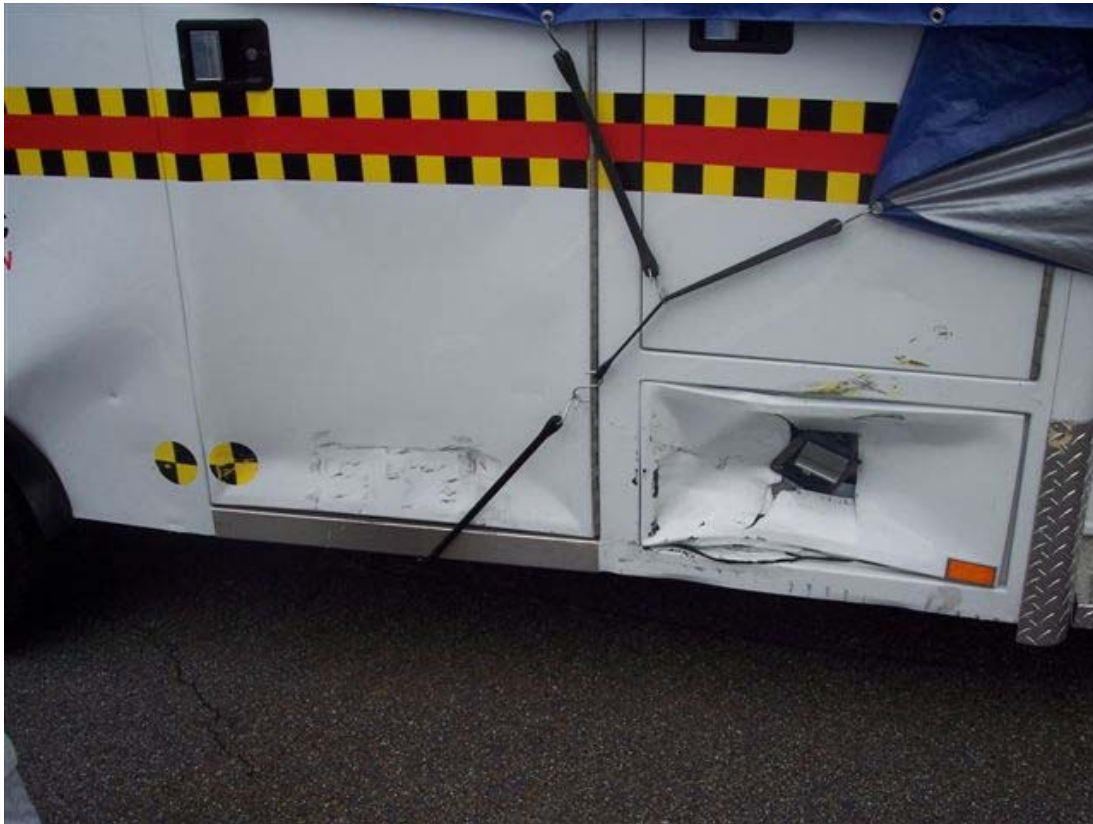
The battery compartment was bent in and the latch was destroyed. The left side lower storage compartment doors were bent in. The storage compartment floor and framing was distorted.

OVERALL VIEW OF RIGHT SIDE SHOWING DAMAGE TO PERSONNEL DOOR AND BATTERY COMPARTMENT (TEST 052)

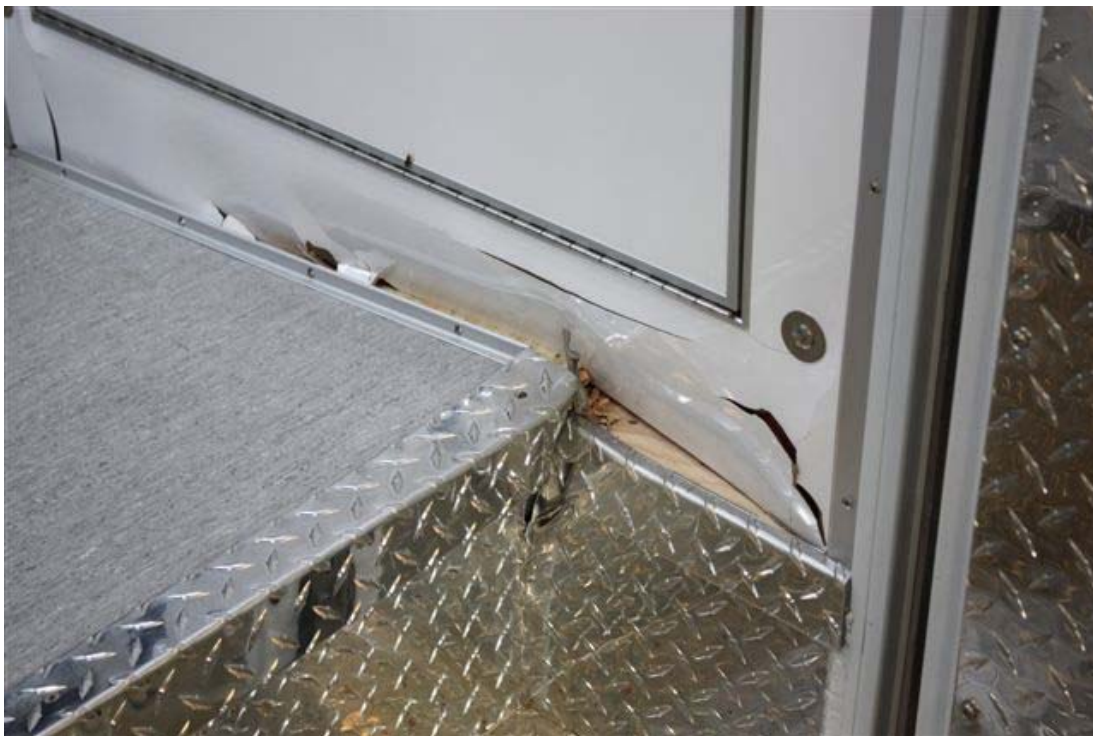
There was some minor separation and bending along the joint between the floor and wall behind the hinge side of the patient compartment door.

VIEW SHOWING DAMAGE INSIDE PERSONNEL DOOR (TEST 052)

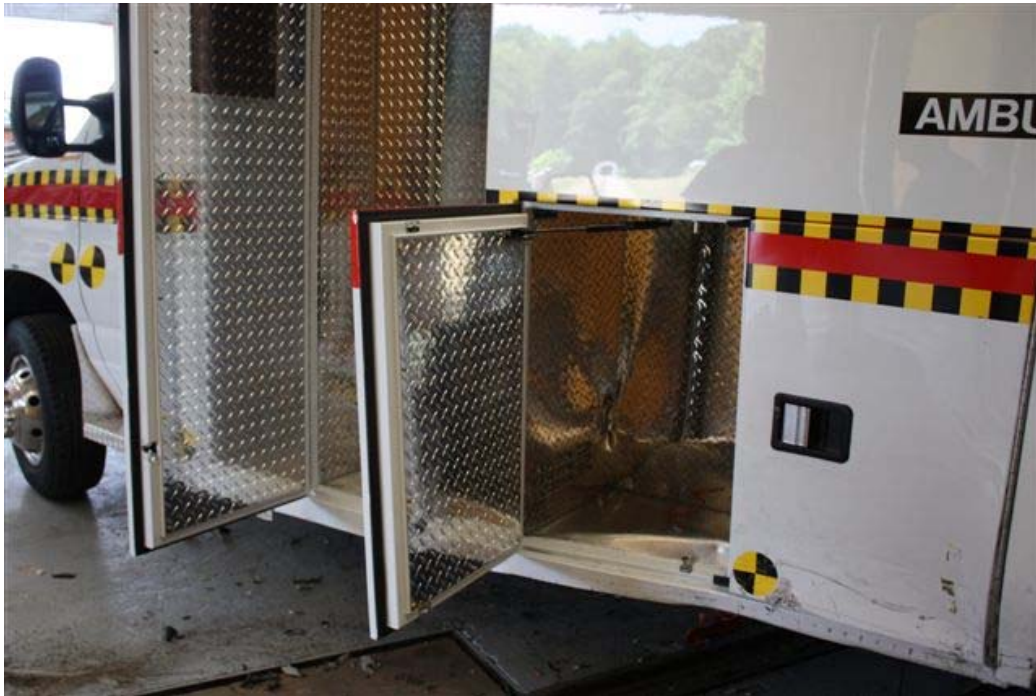
VIEW SHOWING DAMAGE TO INTERIOR OF LEFT SIDE STORAGE COMPARTMENT (TEST 055)

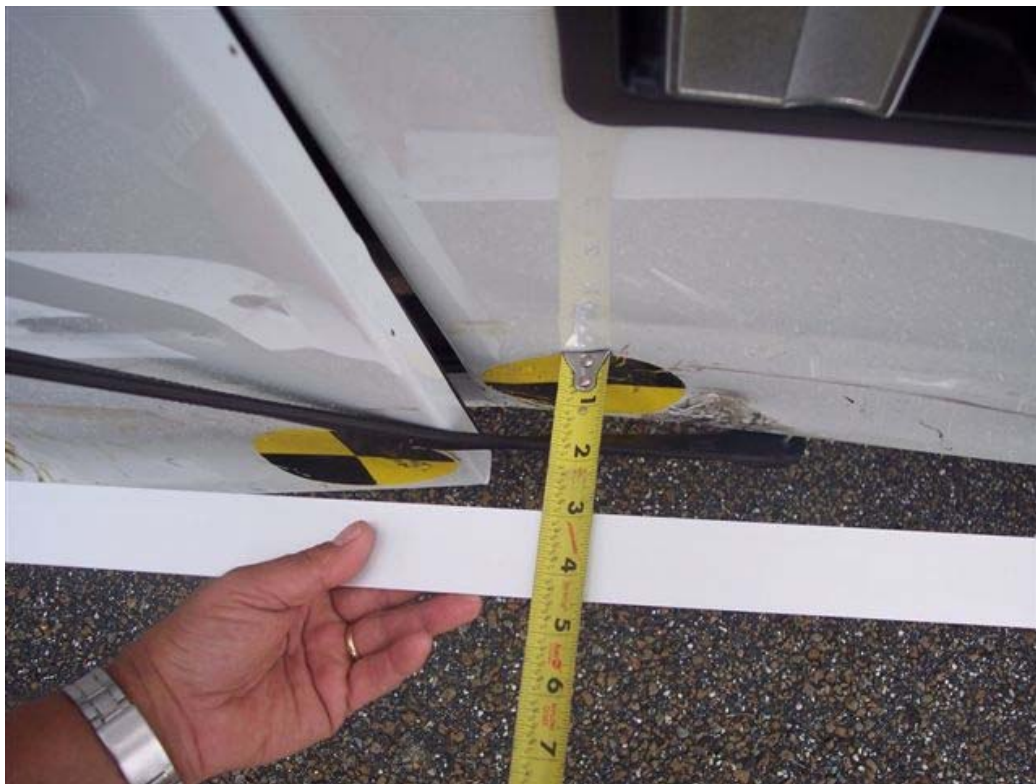
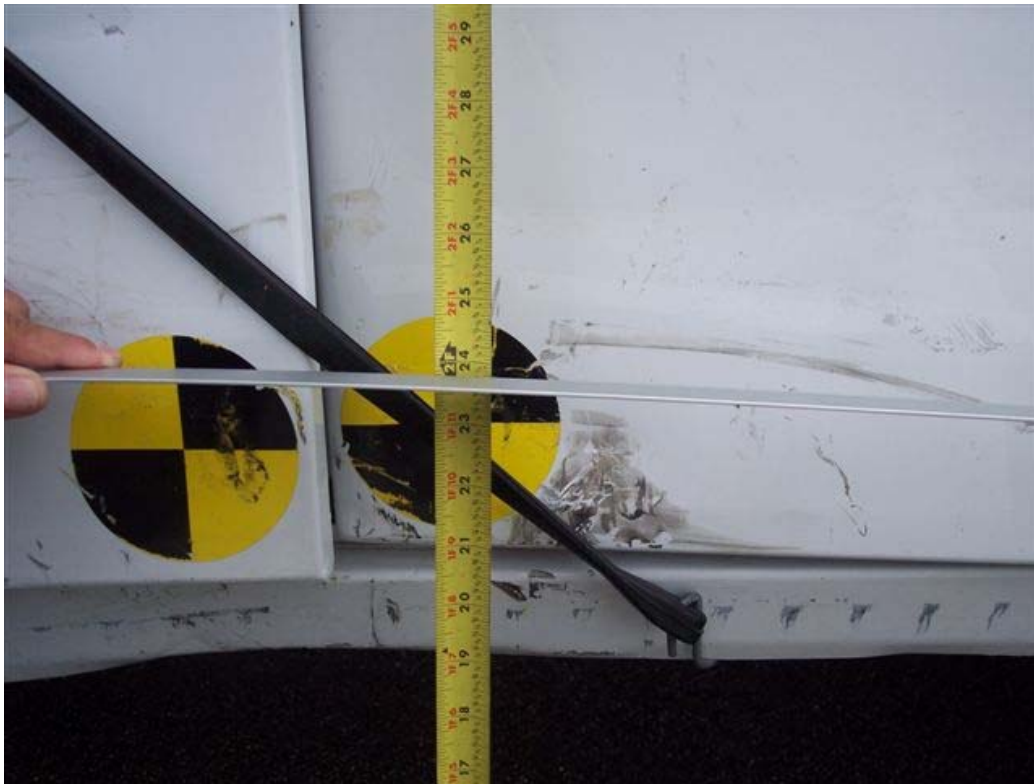
LEFT SIDE IMPACT SHOWING MEASUREMENT OF MAXIMUM CRUSH (TEST #055)

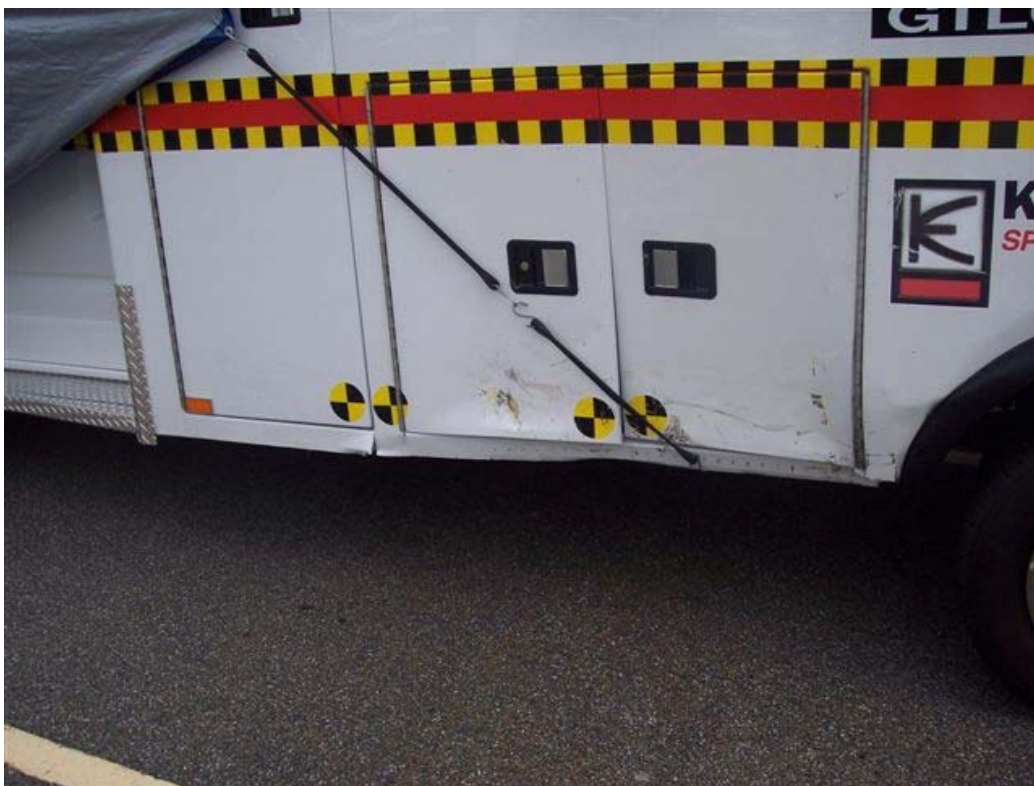
OVERALL VIEW OF LEFT SIDE DAMAGE (TEST #055)
